Human Error Analysis of the Macondo Well Blowout

Patrick K. Smith¹, Haley Kincannon², Ryan Lehnert², Qingsheng Wang³,
and Michael D. Larrañaga¹

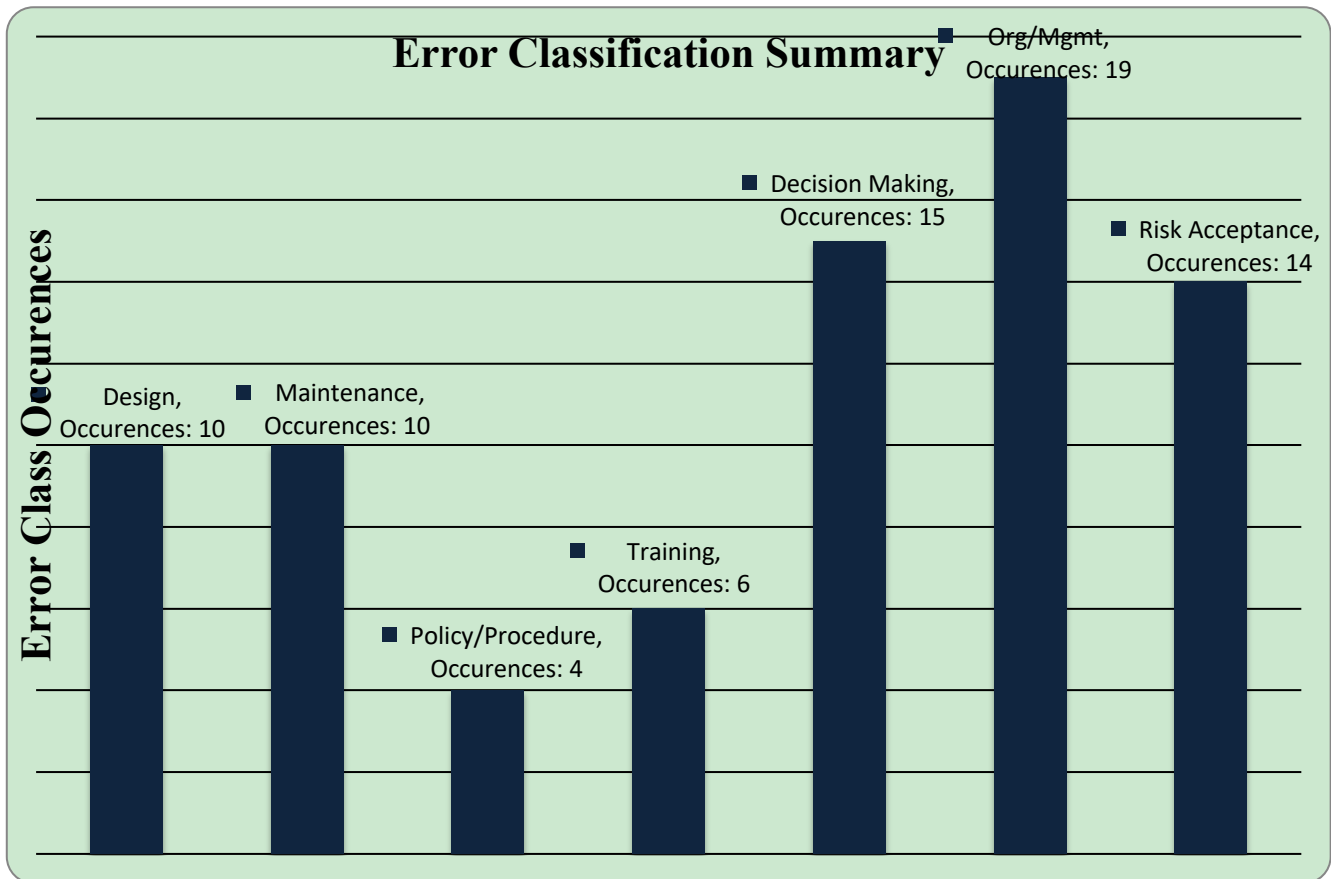
Based on the data contained in Table 1, it is concluded that the majority of the errors (20 out of 25) leading up to the Macondo disaster are latent errors, and are attributable to the organization as a whole. Figure 1 summarizes the number of errors that are considered to be significant contributors to the incident. The figure shows that 19 errors can be classified to the errors in organization or management caused by poor leadership. The results indicate a weakness in the safety culture which needs to be improved immediately in the future.

Figure 1 – Macondo Incident Error Classification Summary
