Human Error Analysis of the Montara Well Blowout

Patrick K. Smith¹, Benjamin N. Craig¹, Qingsheng Wang², Michael D. Larrañaga^{1,3}

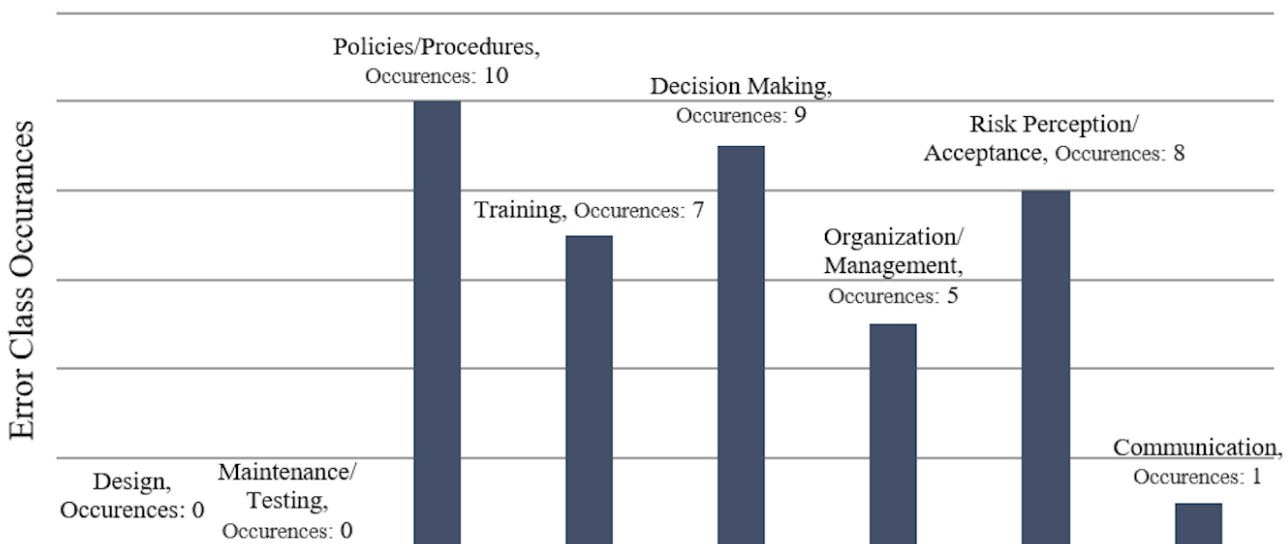
Figure 1. Montara incident error classification summary.

Based on the data contained in Table 1, it is concluded that 83% of errors which led up to the release at the Montara wellhead were latent errors (10 out of 12) and are attributable to policies and procedures in place at the time of the incident. Figure 1 summarizes the number of errors that are considered to be significant contributors to the incident. Table 1 shows a majority of the identified errors relate to guidelines described in API RP 75 and may have prevented the release they had been in place.
